Final Report

Engineered Geothermal System Demonstration Project

Northern California Power Agency, The Geysers, CA

AltaRock Energy, Inc.
Seattle, WA

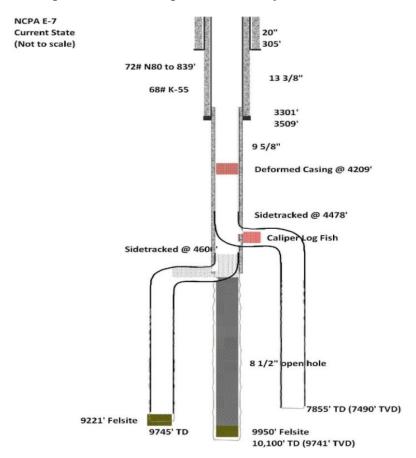
Figure 1. Existing well E-7 conditions prior to well workover.

If the serpentinite that serves as the cap to the steam reservoir in the Geysers is exposed to fresh water, it can become very weak and even flow, making drilling through this formation very difficult. Most of the wells drilled through the serpentinite cap in the Geysers were drilled in the 1980's, before widespread water injection began in 2003 (in the case of the southeast Geysers). Well bore stability problems were recently reported in several wells in the Bottle Rock area, and largely attributed to hydration of the formation by injected water. The problematic lithology at Bottle Rock is argillite, which is similar to, but somewhat more forgiving, than the serpentinite. The extent to which the serpentinite may have been hydrated and weakened by E-pad injection prior to AltaRock's efforts to re-drill E-7 is difficult to ascertain. In 2008, prior to injection, the E-7 casing appeared to be in good condition except for the damaged collar at 4207 feet.

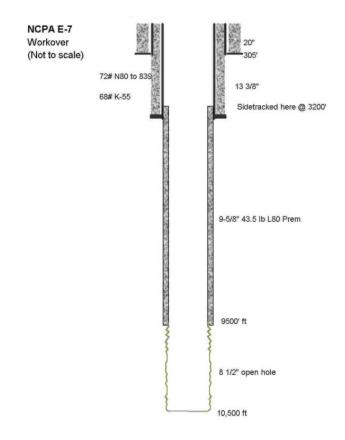
A well workover plan was presented in the application to the DOE in response to the FOA (Figure 2). The plan was to deepen well E-7 2000 feet into the felsite unit by re-drilling the well from 3200 feet bgs to 10,500 feet bgs and then creating an EGS in the felsite instrusive. A 9 $^5/_8$ inch casing was to be set to 9,500 feet bgs (casing shoe depth), below which would be a 1000 foot interval of 8.5 inch open hole (Figure 2Figure 2). The 1000 ft cased interval in upper felsite (8500-9500 feet bgs) was to be a buffer between the overlying commercial steam reservoir and the EGS zone. This buffer was required by the field operator NCPA to separate the "normal" Geyers steam reservoir from the planned EGS reservoir.

Figure 2. Idealized schematic of original well workover plan from proposal (sidetracks not shown)..

The lack of success in deepening the E-7 well may be related the previous use the well as an injector. Water injected at the shoe of the casing 4600 feet bgs (Figure 2) would only have to migrate about 140 feet horizontally to hydrate serpentinite at the shallowest depth of the first re-drill (E-7 RD3). The RD4 and RD4A re-drill boreholes were further away at about 800 horizontal feet. Hydration of the serpentinite may also have occurred due to annular flow outside the casing. This would result in serpentinite instability just outside the two windows that AltaRock cut in the casing to initiate each re-drill. The E-7 RD3 window did eventually became unstable and tight which could have been due to serpentine hydration during weeks of drilling rather than pre-existing conditions. No tightness was reported at the depth of the window of E-7 RD4. Water injection could have resulted in hydration and destabilization of the serpentinite and contributed to the drilling problems encountered in attempts to deepen E-7.

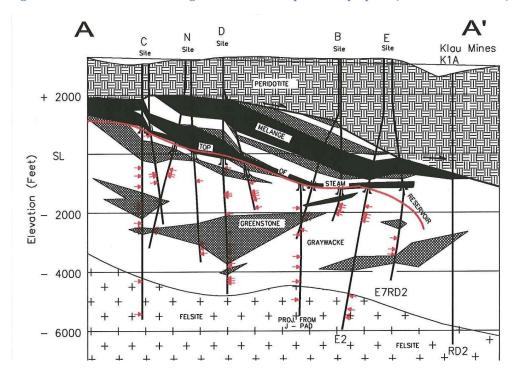
Figure 3. Lithologic Section at possible windows in casing.

The well plan included a window depth at 3200 ft bgs (Figure 3) to accommodate the new 13 $^{3}/_{8}$ inch casing, which had to be sidetracked from the well bore within the existing 13 $^{3}/_{8}$ inch casing (Figure 1). The plan was to set a cement plug in the existing casing, place a whipstock in the well and mill a 12 $^{1}/_{4}$ inch hole, and extend 9 $^{5}/_{8}$ inch casing up to about 9,500 ft bgs. This varies considerably from typical well completions in the Geysers in that well sidetracks are typically started in the more competent bedrock encountered below the serpentine caprock, as previous sidetracks have been completed in well E-7. Deviating the well bore through the serpentine would prove much more problematic than AltaRock was led to believe.

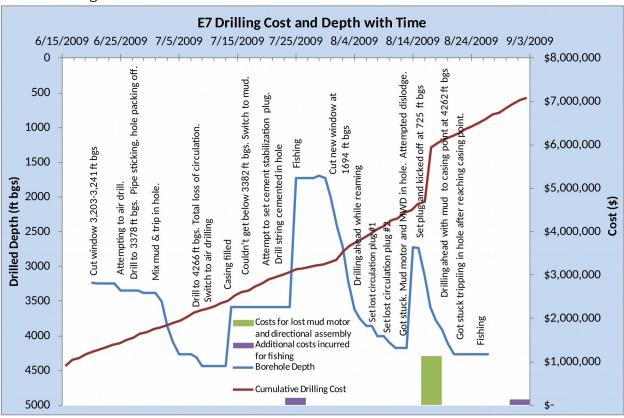
drilling history is summarized below and in Figure 4 and detailed in Appendix A. All the depths described are given in feet bgs.

Figure 4. Drilling progress and cumulative project costs over time. The bar graphs at the bottom of the graph illustrate the material and tool costs associated with fishing work and loss of drilling equipment; standby and labor costs are not included. The graph is annotated to show the timing of significant events.
